Moderate seismic activity and architectural heritage: methodological aspects and application in Wallonia

Abstract

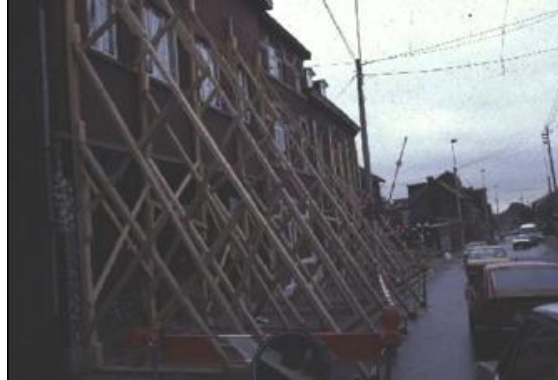
Figure 1 – Consequences of the Liège earthquake on November 8, 1983 ($M = 4.7$)

The regions of northwestern Europe from the Rhine valley to the southern North Sea are characterized by a weak seismic activity compared to the most active regions of the world. Nevertheless, nearly each year, some earthquakes are felt by the population and, regularly, they cause damages to buildings that are sometimes significant (fig. 1.)

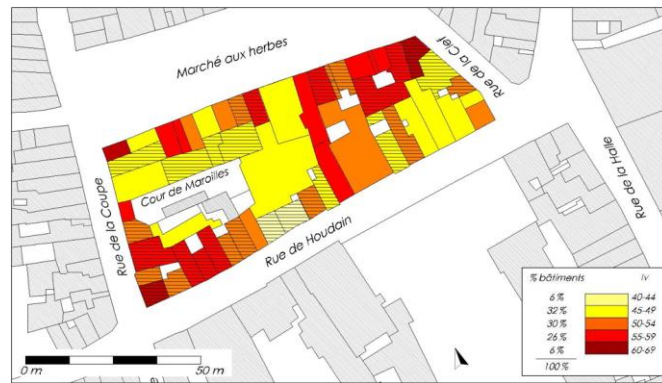
Figure 3 – Determination of the vulnerability index V_i in a part of the historical centre of Mons [5]

In the framework of a recent master thesis, we evaluated the vulnerability for the different houses of a block in the historical center of Mons [5]. This evaluation has been done in different phases, based on the basic and urbanistic typologies and on the typology of the face, and in function of aggravating factors. It

considers 11 parameters fundamental for the building resistance to earthquakes, as the ceiling rigidity or the state of the construction. These parameters come from the Italian experience [6] and are based on the inventory of damages observed during past earthquakes. They have been adapted to the characteristics of the Belgian framing. In a first step, a basic vulnerability index (V_i) is determined based on the typologies of a building. In a second step, particular characteristics not always observable from outside of the buildings have been investigated. The sum of the basic index and the penalties based on those particular characteristics is then calculated to estimate the vulnerability index. The analysis in a district of the historical centre of Mons is shown in Figure 3.

The presumed vulnerability (V_i) of the buildings of the studied block in Mons is high. It indicates that more than half of the buildings could suffer important damages for the value of the peak ground acceleration to take into account in the Eurocode 8 building code. Buildings at the corners of the street and very irregular or willowy constructions are the most vulnerable.

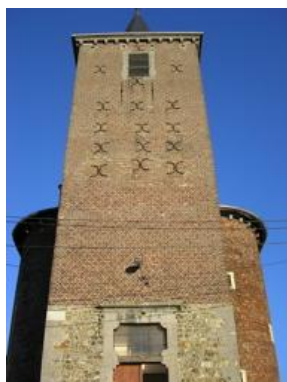
Figure 4 – Saint-Lambert church in Petit-Hallet [10]

In the framework of another master science thesis [10], we developed a trans-disciplinary methodology helping to detect traces of seismic damages of legacy buildings. This was then applied to a case study, the Saint-Lambert church of Petit-Hallet (figure 4).

Numerous cracks on or down to the openings and at the vault level, the fall or the rocking of keystones and the presence of numerous anchors on the tower face are some of the pathologies observed on the church of Petit-Hallet.

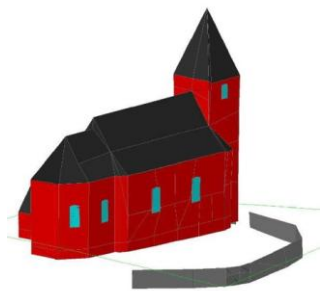
Figure 5 – Typological study [10]

The typological study allow us to list the characteristics of vulnerability to earthquakes as the thickness of walls, the asymmetry in plane and elevation, the simplicity of form of the building, the recess or projection of parts of buildings ... In the case of the church of Petit-Hallet, we conducted a specific analysis to identify the major part of these characteristics of vulnerability (figure 5).
